Fireplace Extraordinaire

Cleaning Procedure

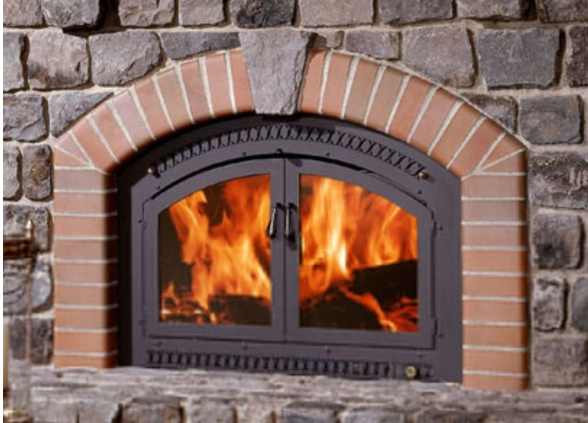
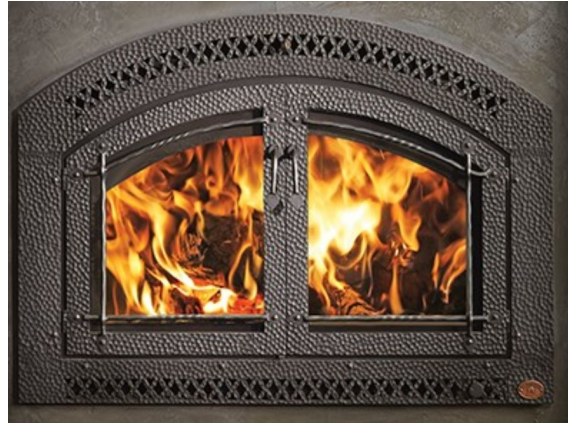
1. Moisten the **glass** with Windex
2. Remove the **Baffle plate** from under the damper opening
3. Open The **Damper**
4. **Sweep** with 12" Viper brush (keep vacuum hose inside firebox)
5. **Open & Close** the Damper repeatedly to shake off the soot
6. Reach in and **remove** soot from damper opening ledge
7. Remove Gently and Clean the **Catalytic Combustor** (you may need to remove nuts with ratchet tool, **WD-40 helps - don't snap the nuts off!**)
8. Reinstall the catalytic combustor saving as much of the **gasket** as possible
9. Reinstall metal screen combustor **Guard**, you may need to bend the tabs
10. Clean the **firebox**
11. Clean the **Glass**, if needed use ONLY NEW Razor Blade
12. Slide you head inside the firebox Look up the Chimney with a Flashlight and **Inspect** for bulges.
13. Inspect the **Cap** from Outside, clean if necessary.

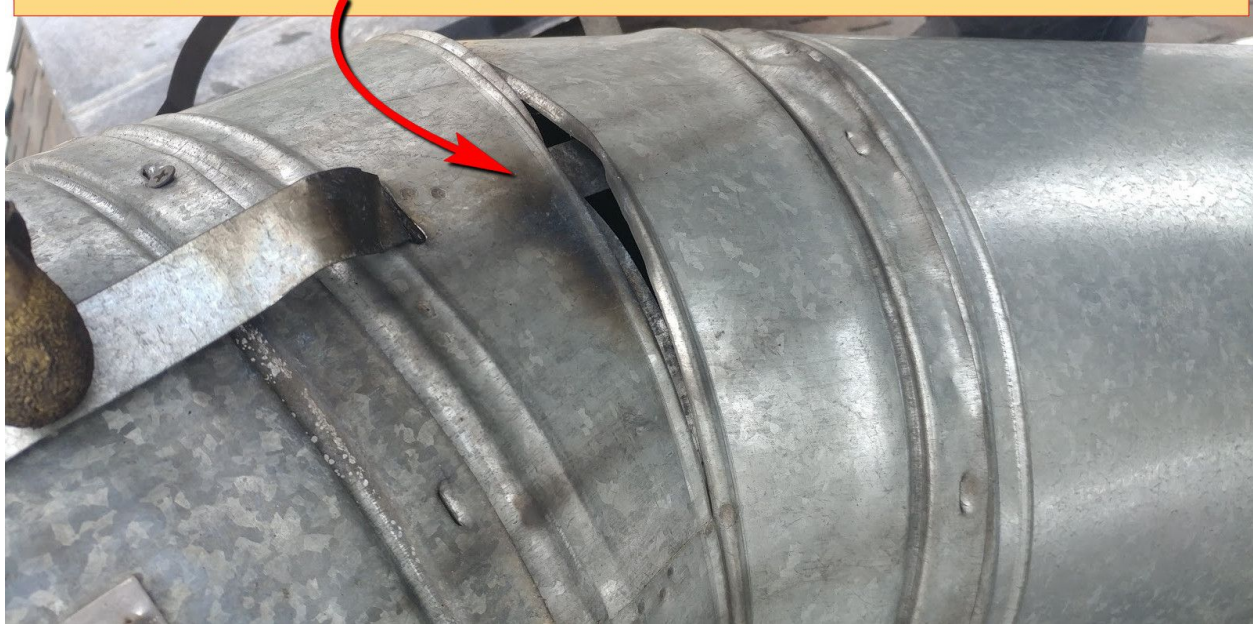
Elbow joint of outer pipe split - soot marks mean breach

A photograph showing a vertical section of a double wall pipe. The pipe is made of galvanized metal and has several horizontal bands. A red arrow points to a hole in the lower section of the pipe, indicating a breach. The pipe is surrounded by wooden framing and some white tape.

3. Chimney joint disconnected within the structure

EFFECT: House Fire danger! Do not use fireplace until repairs are made

SOLUTION: Access chimney chase from top or wall and replace or reconnect the pipe Sections.
