PYROLISYS

Please read this if a development of dangerous conditions has been observed in your chimney system.

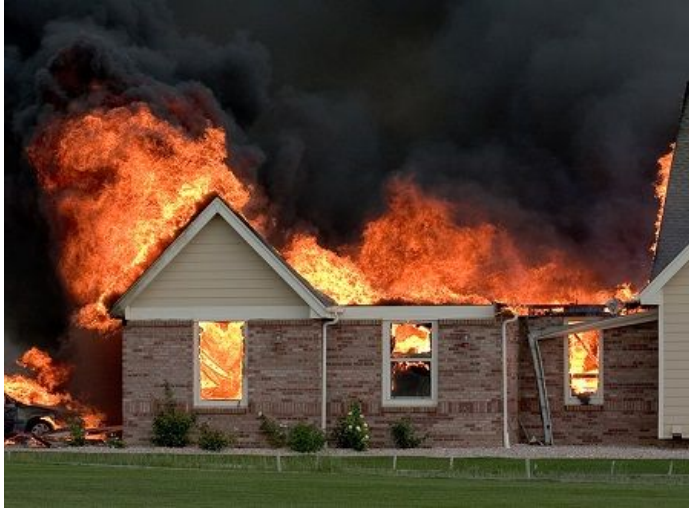
This may be simply due the chimney's age or as in most cases as a result of exposure to chimney fires. Chimney fires are not uncommon especially with outdated non EPA-certified appliances. Their low efficiency (usually around 35%) and incomplete combustion promote heavy creosote build-up on the inner walls of the flue. The

creosote accumulation is even higher with poor fuel such as pine, fir, unseasoned wood or cardboard. The more buildup there is the more easily the creosote ignites during a "hot fire" session. When the creosote in your chimney ignites it creates a sudden spike of temperature in the flue **up to 2100F** from a few seconds to a few minutes. Such high temperatures can **over-expand and distort** the inner walls of the chimney leaving them far from their original form. These distortions in form of ***Bulges, Dents and Warp*** can compromise the thermal integrity of the chimney and fail to protect the combustibles surrounding the chimney from additional heat during further use of the system or yet another chimney fire in the future which can lead to "breach" or ***Pyrolysis***.

It is highly recommended that the chimney system be replaced for safety along with the outdated appliance which, if left in place, could accelerate the deterioration of a new system.

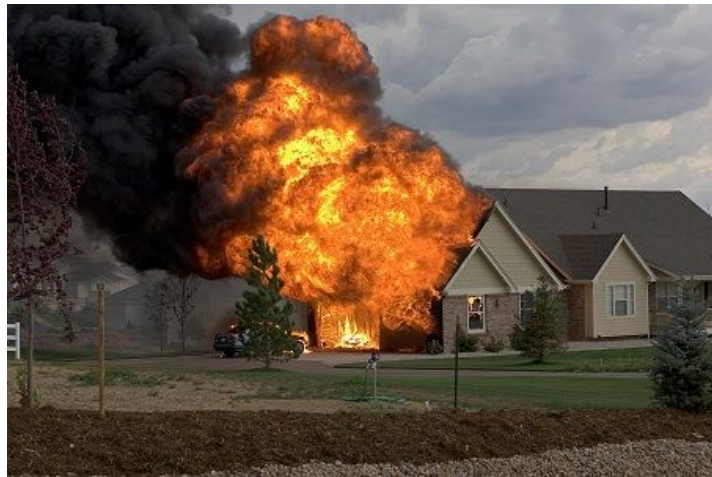
Special note: with ***solid-pack, double wall insulated chimney pipe*** (aka metalbestos brand) there is an even higher risk of **Pyrolysis**. These old double wall pipes used to be loose-filled, which means that the the space between the inner and outer wall of the pipe was filled with loose silica

(white powder). When the chimney suffers bulges, the two chimney walls are not so tightly together anymore and the bulges make space for the silica to “settle” into the bulge cavity. This “settling” means that there is now silica missing from some area in the pipe creating a **hot spot**

(an area where the silica doesn't stop the heat transfer to the outside of the pipe) and with several bulges there is going to be several hotspots. Hot spots are very dangerous because they can really speed up the pyrolysis and expose the surrounding combustibles to heat much higher than 212F. So even if the flashpoint of the wood drops to 400F, having the chimney exposed to 500F will make it combust.
